AVOIDANCE OF MV SWITCHGEAR FAILURE CASE STUDIES OF ON-LINE CONDITION MONITORING

This paper considers, through a series of practical case studies, the avoidance of major incidents through the targeted use of on-line condition monitoring of MV indoor switchboards. A technique to pin point the location of partial discharge (pd) using time of flight measurement techniques is discussed.

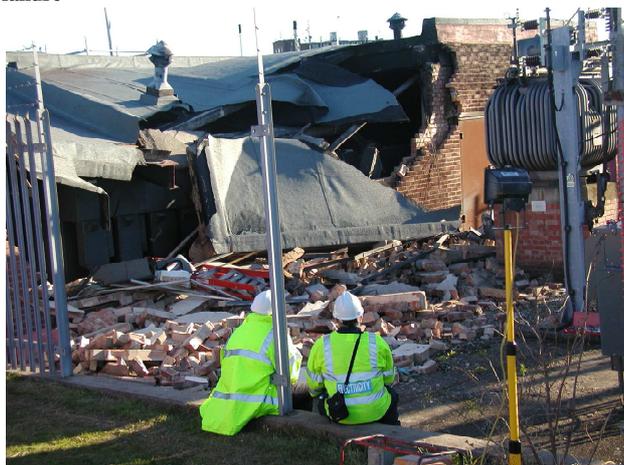
Figure 1 Damage to substation following a catastrophic switchgear failure

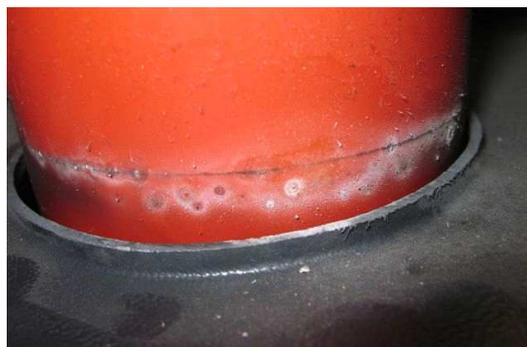
AA sensors detected partial discharge on a bus section circuit breaker and a bus coupler circuit breaker at Merton substation throughout 2008. Investigation revealed discharge between the circuit breaker bushing and the lid of the vacuum bottle shroud. The particular circuit breakers were found to be very dirty with greasy dust covering the bushings as can be seen from figure 3.

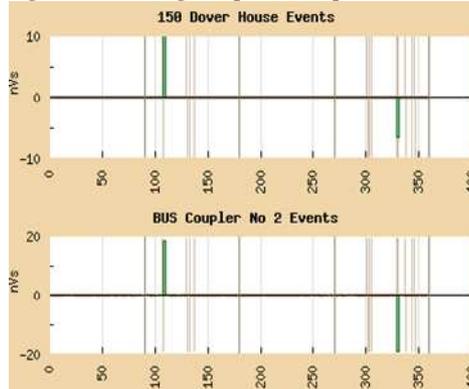
From figure 7 it is thought that one of the discharges originates at Panel 18, 19 or 20. Simultaneous switchgear pd was acquired by the CCs as illustrated in figure 8. The first pulse in the cycle in each case is clearly from the same pd source. The pulses are displaced in time with the pulse arriving at the sensor connected at BC2 before it arrives at Panel 24 (Dover House) as shown in figure 9.

Figure 8 Switchgear pulses acquired over one power cycle
